# Manhole Inspection Summary

Manhole # S11II\_021MH

**Location** Address: **1814 ROSEDALE ST** Cross Street: **WESTWOOD AVE**

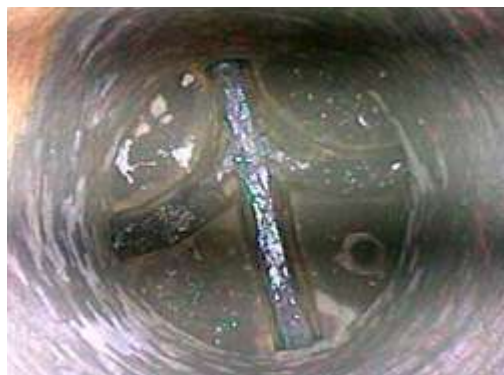
Top View

**Frame** Offset: **1** (in.) Condition: ☒ Sound ☐ Cracked ☐ Leaks

FRAME OFFSET

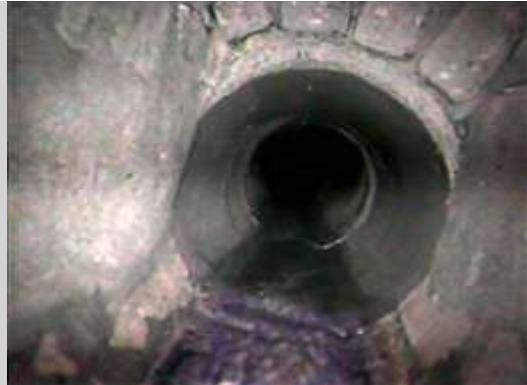
12 O'Clock Outflow

8 in. Circular Gravity Sewer  
Pipe Out @ 12 O'Clock

Pipe Height: (in.) Direct  
Pipe Material: **Clay** ☐ Pipe Lined  
Invert Depth: **9.21** (ft.) Flow Characteristics: **Slow**  
Deposits: ☒ None ☐ Mud ☐ Sludge ☐ Debris ☐ Grease  
Silt Depth: (in.) Deposits Extent:  
Infiltration: **None** Pipe Seal Cond: **Sound**

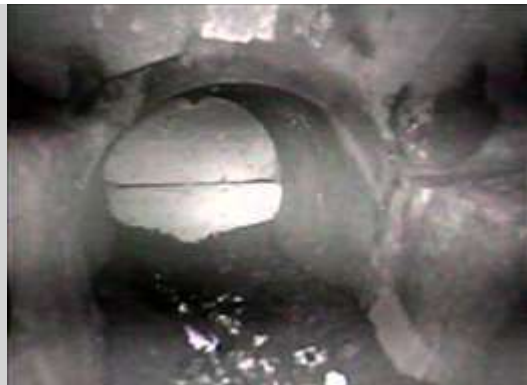
3 O'Clock Inflow

8 in. Circular Gravity Sewer  
Pipe In @ 3 O'Clock

Pipe Height: (in.) Direct  
Pipe Material: **Clay** ☐ Pipe Lined  
Invert Depth: **9.30** (ft.) Flow Characteristics: **None**  
Deposits: ☐ None ☒ **Mud** ☒ **Sludge** ☐ Debris ☐ Grease  
Silt Depth: **1** (in.) Deposits Extent: **Light**  
Infiltration: **None** Pipe Seal Cond: **Sound**

Connects To: **Stub connection / abandoned**

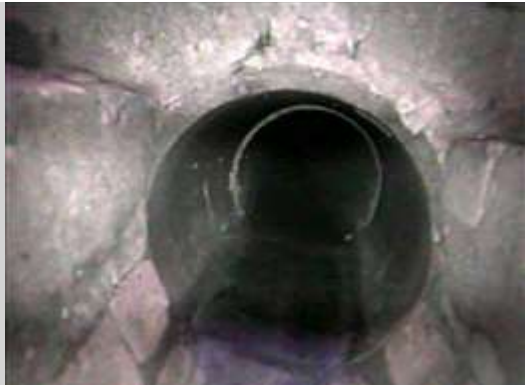
6 O'Clock Inflow

8 in. Circular Gravity Sewer

Pipe In @ 6 O'Clock

Invert Depth: **9.20** (ft.) Flow Characteristics: **Slow**

Deposits: ☒ None ☐ **Mud** ☐ **Sludge** ☐ Debris ☐ Grease

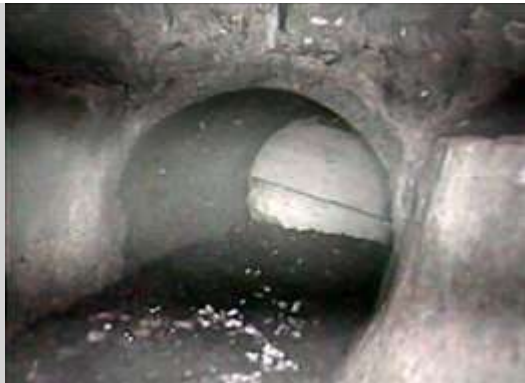
9 O'Clock Inflow

8 in. Circular Gravity Sewer

Pipe In @ 9 O'Clock

Deposits: ☐ None ☒ **Mud** ☒ **Sludge** ☐ Debris ☐ Grease

Silt Depth: **1** (in.) Deposits Extent: **Light**

Connects To: **Stub connection / abandoned**
